Manhole Inspection Summary

Manhole # S33S__031MH

Insp Date: **10/23/08 9:17 AM**

Location Address: **175 w ostend st**

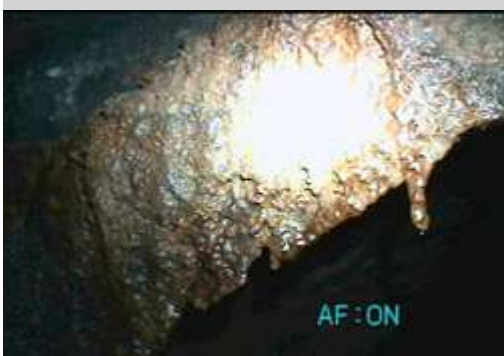
Defect 4

Infiltration: ☐ None ☒ **Joint** ☐ Cracks ☐ Mortar ☐ Roots ☒ **Wall**

infiltration

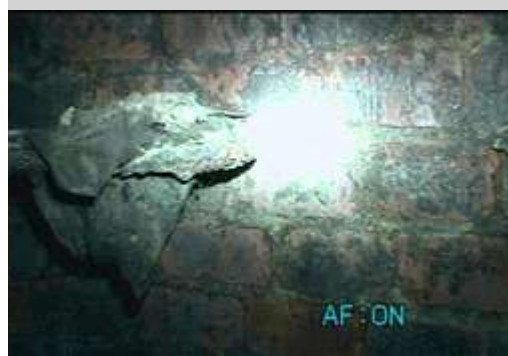
Defect 3

Surcharge ☒ **Evidence Of Surcharge** Depth: **7.** (ft.) ☐ Active Surcharge Present

surcharge evd

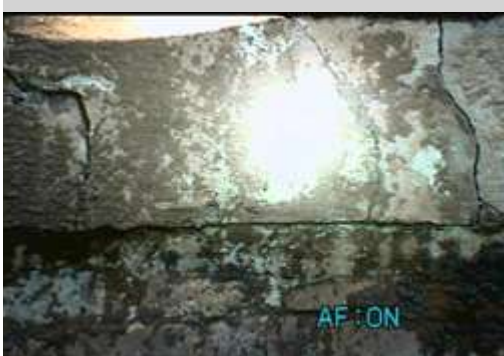
Defect 2

Frame Offset: **0** (in.) Condition: ☐ Sound ☒ **Cracked** ☐ Leaks

Condition: ☐ Sound ☒ **Cracked** ☐ Root Intrusion ☐ Loose Brick ☐ Deteriorated

cracked frame & chimney cracked

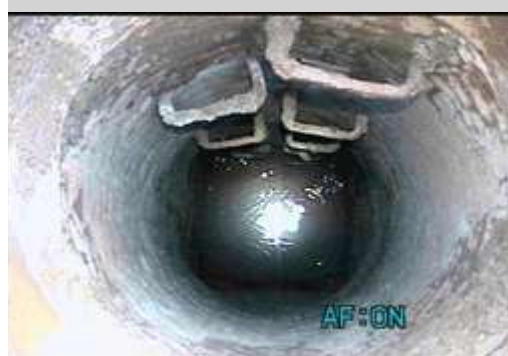
Defect 1

Steps Count: **9** Missing: **0** ☒ **Corroded**

corr steps

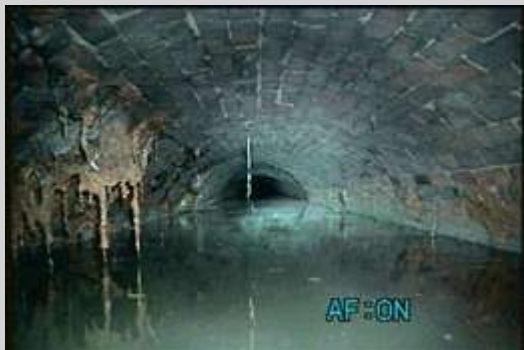
12 O'Clock Outflow

60 in. Circular Gravity Sewer
Pipe Out @ 12 O'Clock

brick pipe

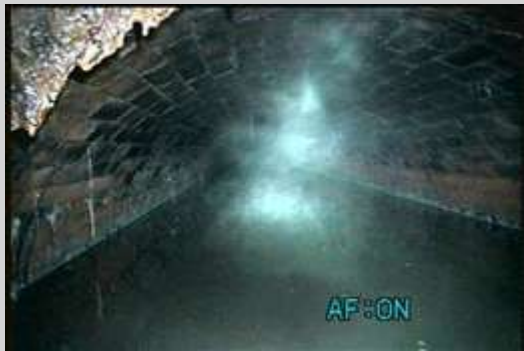
6 O'Clock Inflow

54 in. Circular Gravity Sewer
Pipe In @ 6 O'Clock

brick pipe
